CLOSURE OVERSIGHT ACTIVITIES

**LITTON COMPANY
INSTRUMENTS & LIFE SUPPORT DIVISION
DAVENPORT, IOWA**

TRIP REPORT

TRIP REPORT FOR CLOSURE OVERSIGHT ACTIVITIES

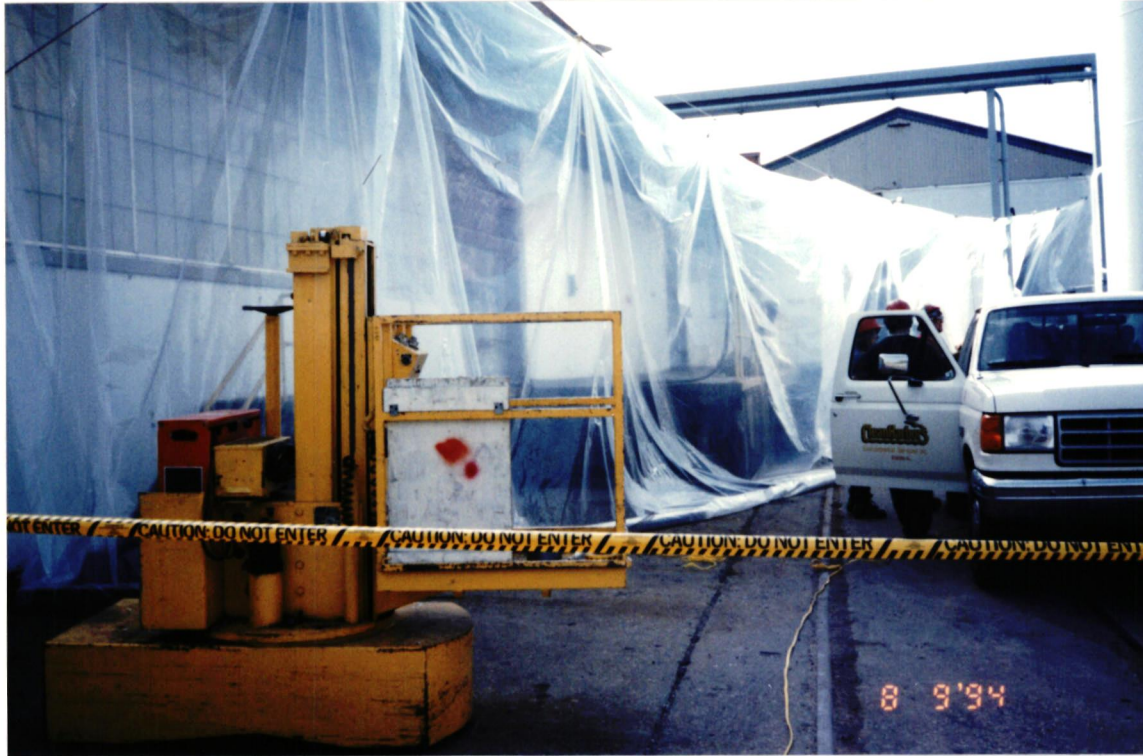
Photograph: 1 Direction: Southeast Photographer: Claudia Vines
Date/Time: 08/09/94, 0855 Description: Plastic sheeting was placed around the loading dock area to minimize the release of sandblasting dust particles.

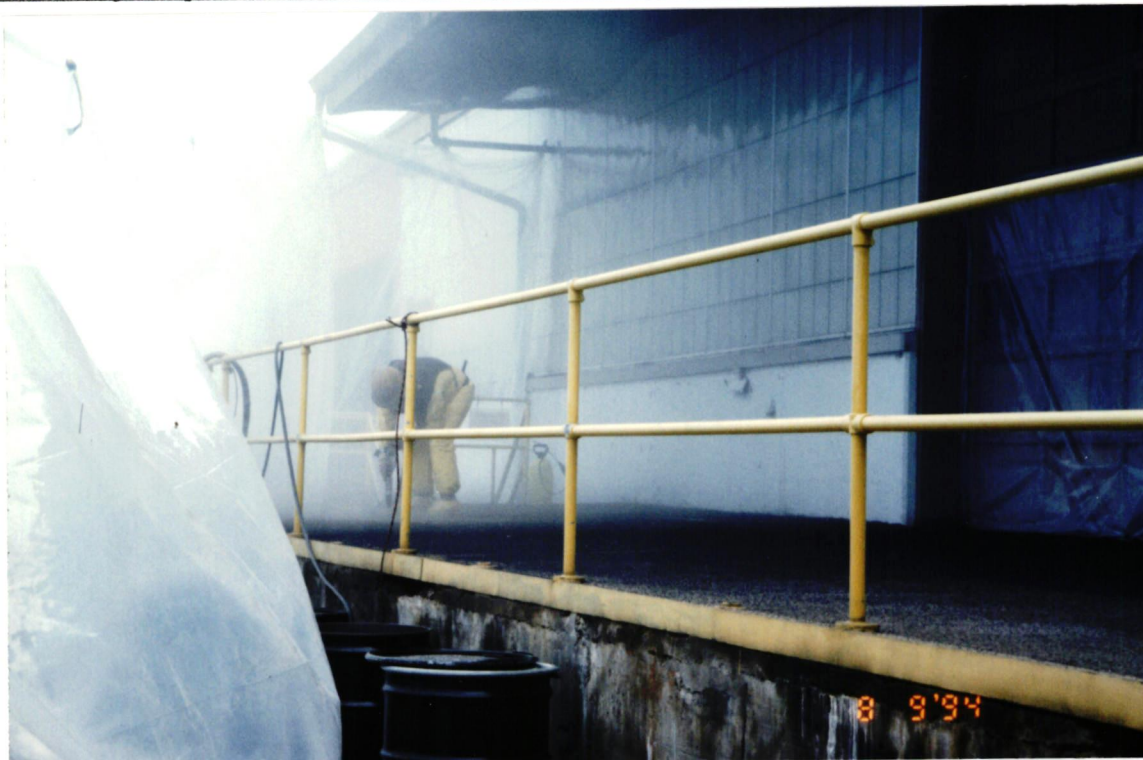
Photograph: 2 Direction: Northwest Photographer: Claudia Vines
Date/Time: 08/09/94, 0935 Description: A thick white dust was visible during sandblasting operations.

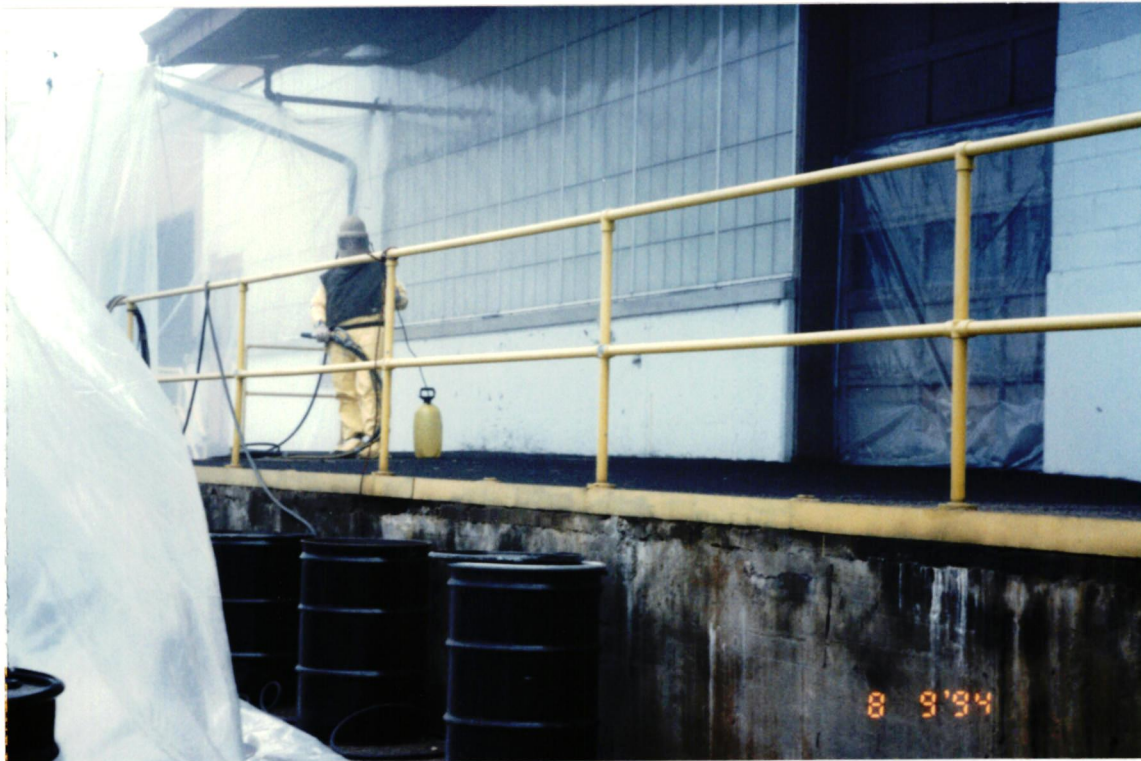
Photograph: 3 Direction: Northwest Photographer: Claudia Vines
Date/Time: 08/09/94, 0936 Description: The work crew used a water mister to attempt to reduce the spread of dust particulate during sandblasting operations.

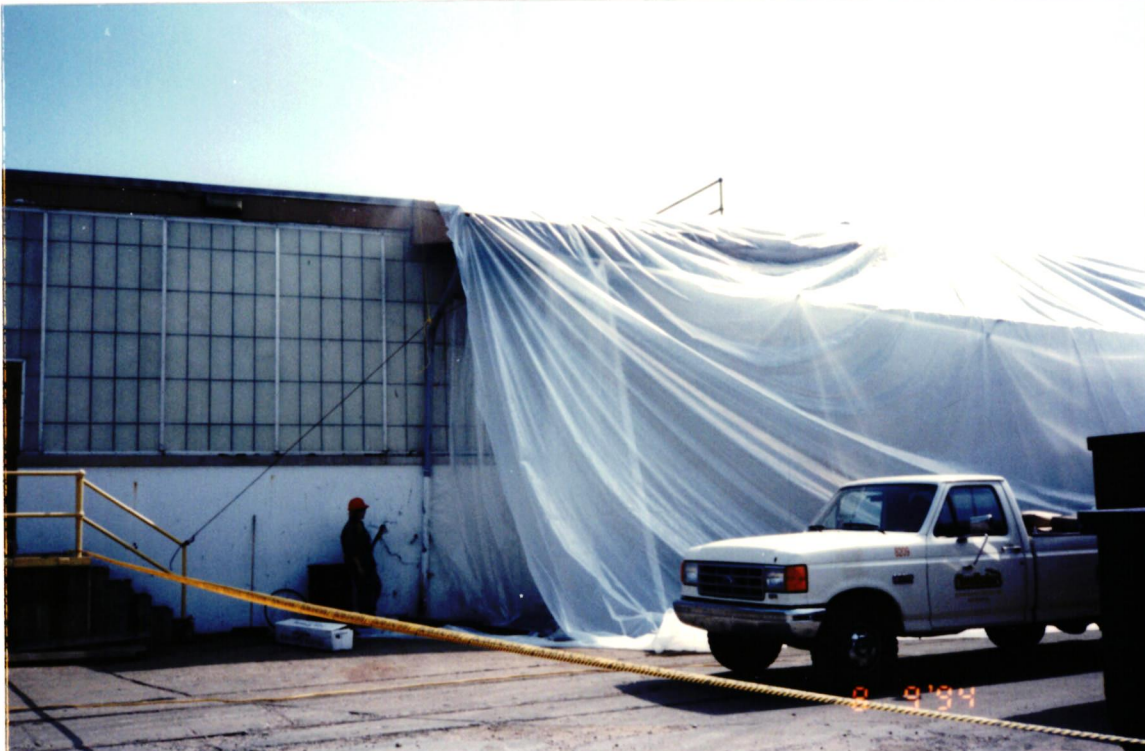
Photograph: 4 Direction: North Photographer: Claudia Vines
Date/Time: 08/09/94, 1051 Description: Plastic sheeting was dropped from the roof of the facility to encapsulate the area to minimize dust release. Dust release did continue, however, at the left upper corner of the plastic.

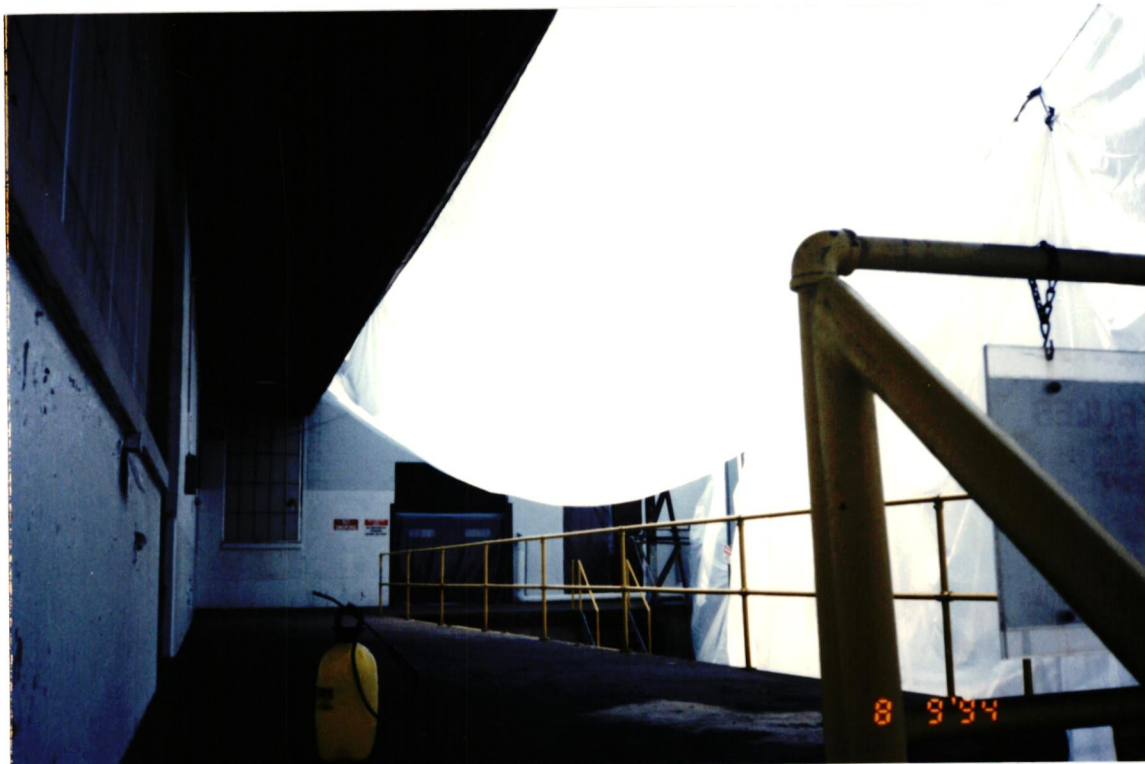
Photograph: 5 Direction: East Photographer: Claudia Vines
Date/Time: 08/09/94, 1040 Description: This photograph shows a view of the plastic sheeting over top of the dock area from inside the encapsulation.

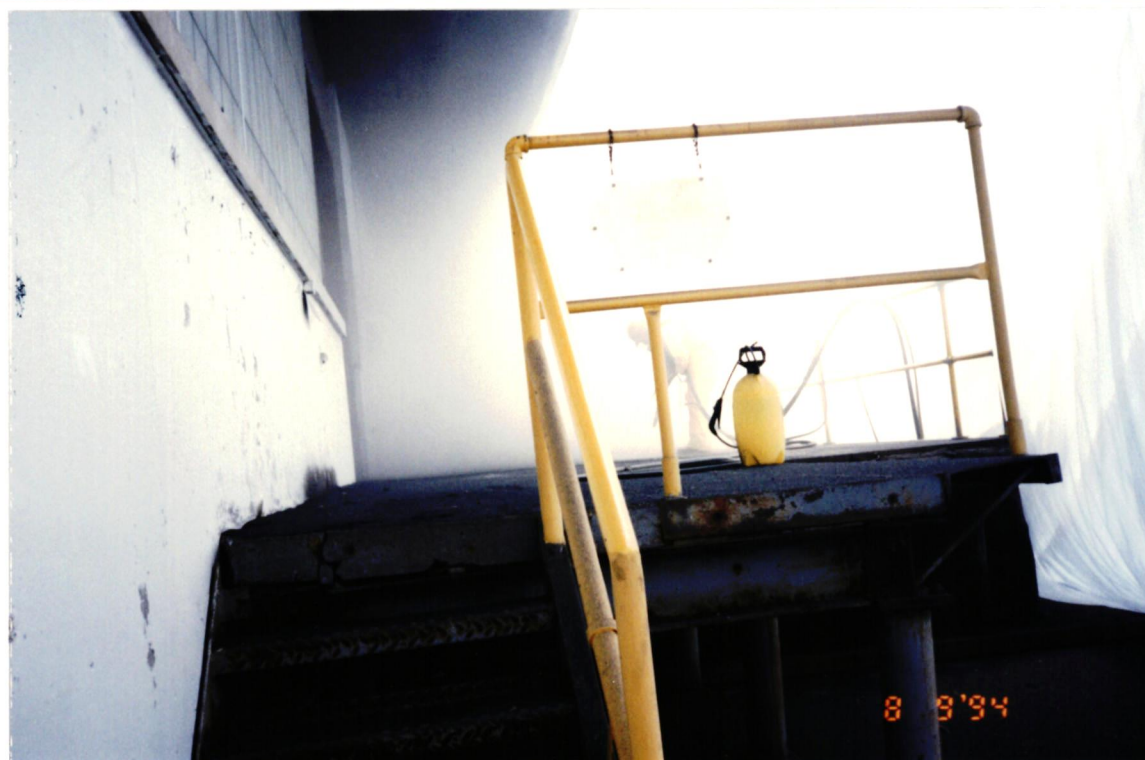
Photograph: 6 Direction: East Photographer: Claudia Vines
Date/Time: 08/09/94, 1123 Description: A thick dust was created by sandblasting operations, resulting in poor visibility inside the encapsulation.

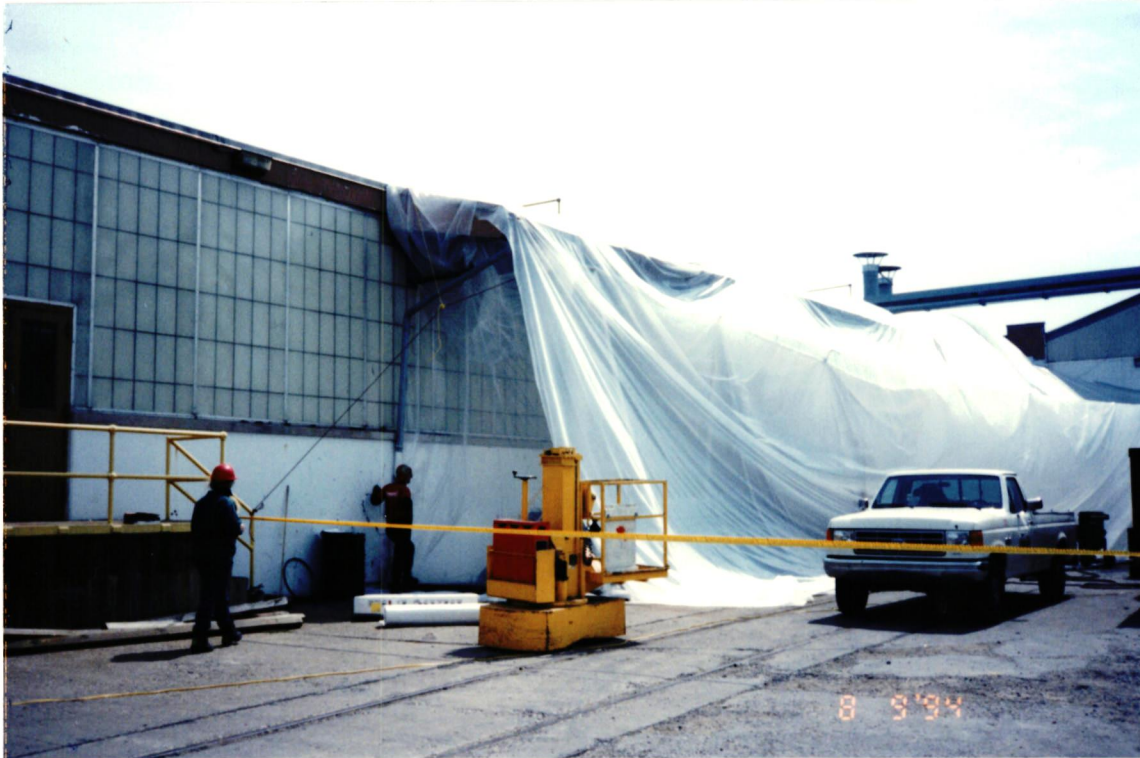
Photograph: 7 Direction: Northeast Photographer: Claudia Vines
Date/Time: 08/09/94, 1125 Description: Another plastic sheet was dropped from the roof to close the air vent on the western end of the plastic sheeting encapsulation.

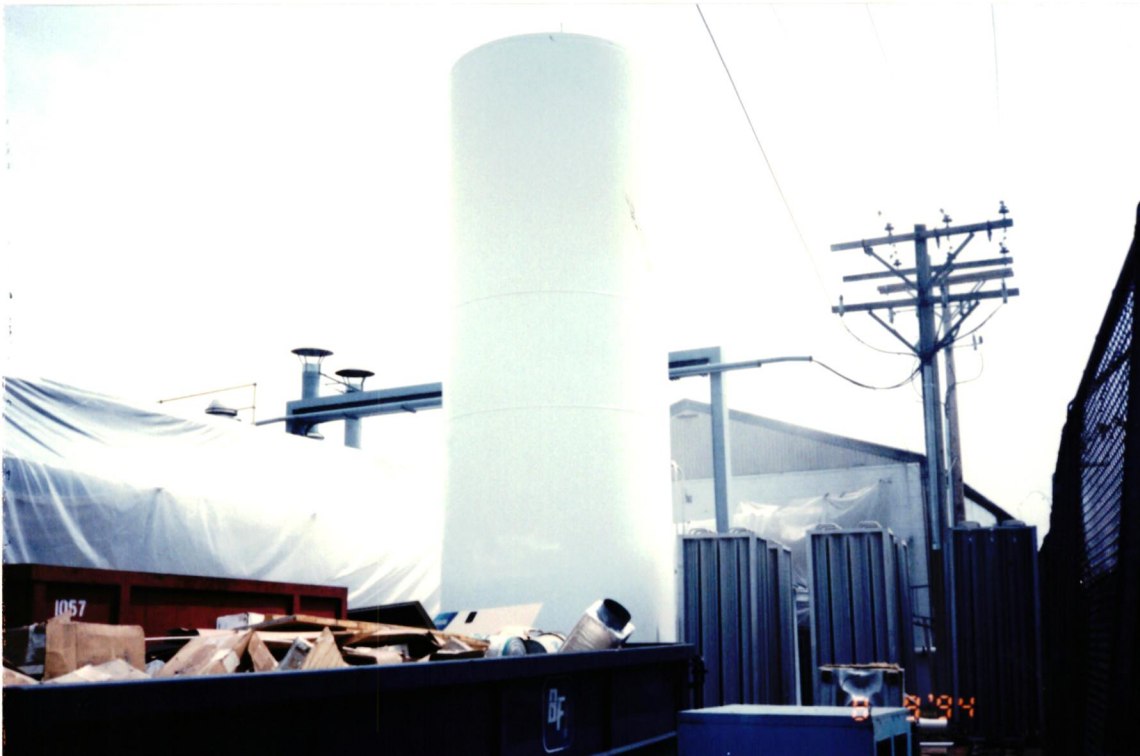
Photograph: 8 Direction: East Photographer: Claudia Vines
Date/Time: 08/09/94, 1255 Description: Sandblasting dust escaped from the eastern end of the plastic sheeting encapsulation.

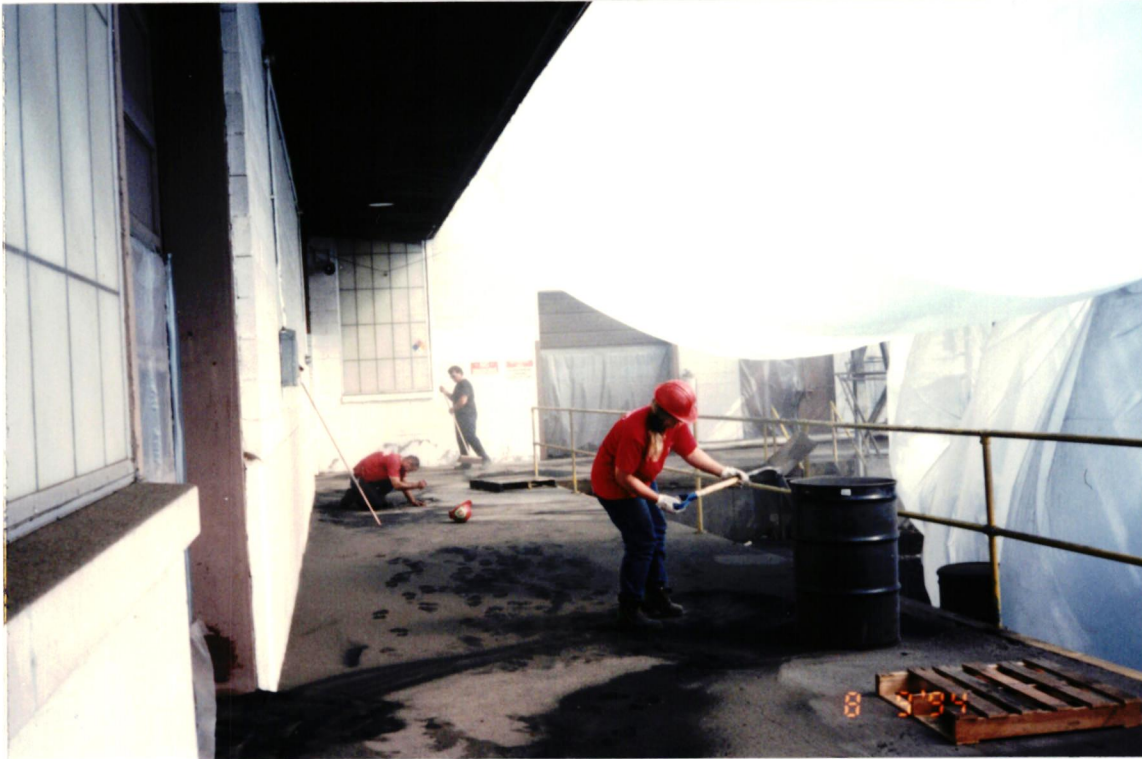
Photograph: 9 Direction: East Photographer: Claudia Vines
Date/Time: 08/09/94, 1630 Description: The work crew is shown shovelling and drumming the sandblasting dust.

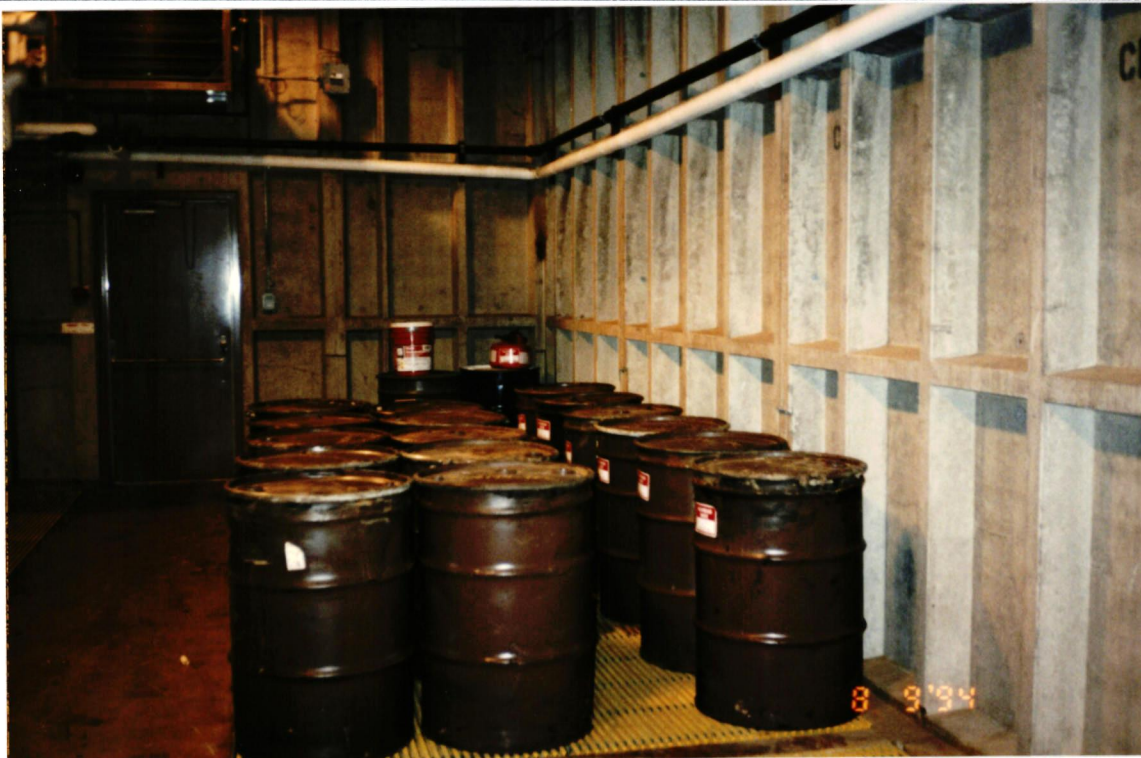
Photograph: 10 Direction: South Photographer: Claudia Vines
Date/Time: 08/09/94, 0850 Description: A view of the facility's current hazardous waste storage area.
